RE: 2nd Floor – Ray Walsh House, 437 Peel St, Tamworth, NSW 2340

FRIABLE VISUAL ASBESTOS CLEARANCE

Report Reference: CLR25772R01

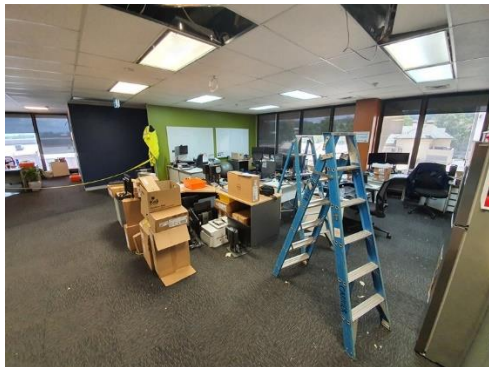
Image 1: 2nd Floor affected area prior to remediation.

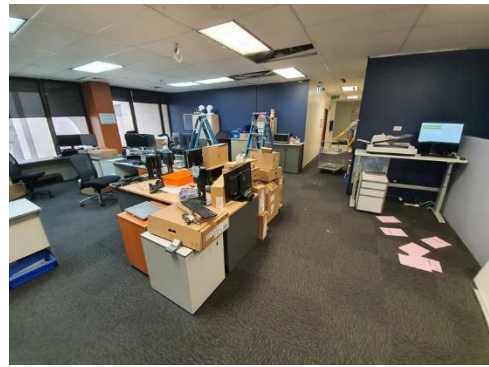
Image 2: 2nd Floor affected area prior to remediation.

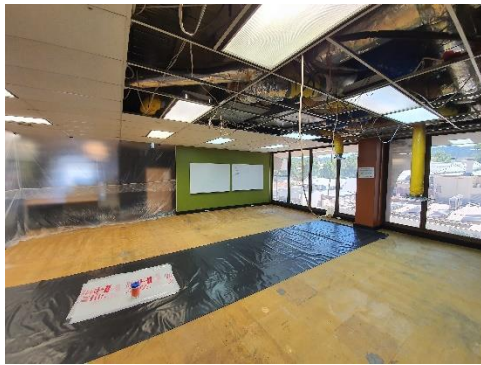
Image 3: 2nd Floor affected area during interim clearance, prior to air conditioner repair.

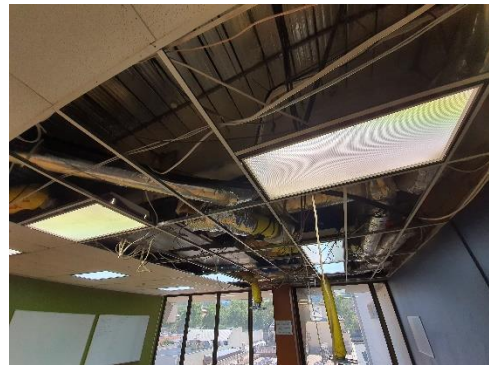
Image 4: 2nd Floor affected area during interim clearance, prior to air conditioner repair.

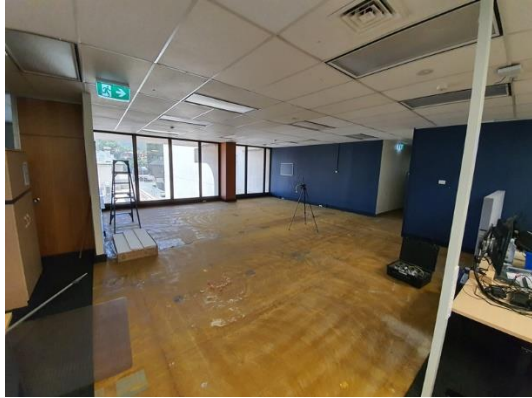
Image 5: 2nd Floor affected area after remediation.

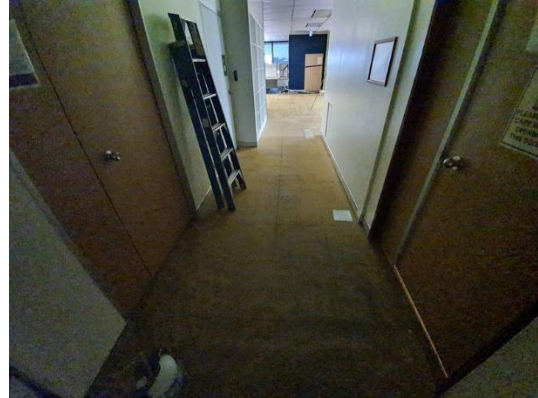
Image 6: 2nd Floor hallway adjacent to affected area after remediation.

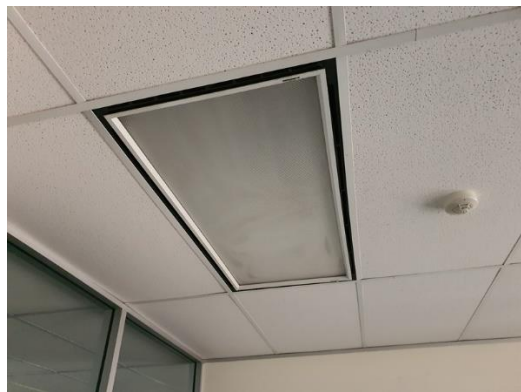
Additionally, two light fittings in a separate second floor office that were found to contain asbestos fibres were cleaned as part of the remediation works.

Image 7: 2nd Floor contaminated light fitting after remediation.

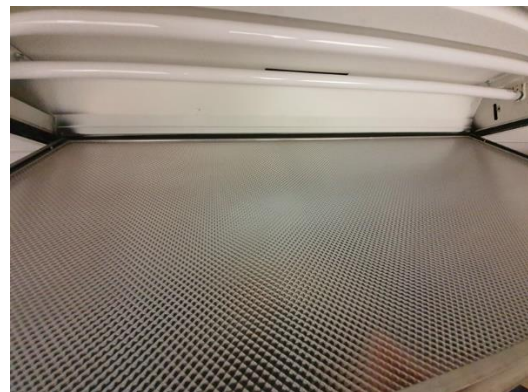
Image 8: 2nd Floor contaminated light fitting after remediation.
