RE: Ray Walsh House, 437 Peel St, Tamworth, NSW 2340

Recommendations for the Remediation of the 5th Floor Air

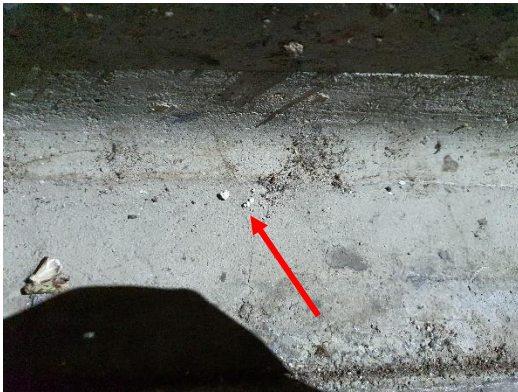
After a recent inspection by Tamworth Regional Council staff, possible asbestos containing insulating materials were sighted on the plant within the main area of the 5th Floor, as well as on plant and the floor inside the air conditioner filtration rooms.

Image 1: Filter Room - Vermiculite debris

1. The vermiculite within the filtration system should be removed. Remediation via encapsulation is high-risk due to the poor condition of the material, which is likely to fall and cause further contamination should too much weight be added or if it is disturbed. Encapsulation is therefore not recommended.

2. Once removal is complete, the filtration rooms will need to be cleaned to remove all asbestos-containing debris and dust. This includes any hard surfaces such as the walls, floors, ceiling, and plant. Wet-wiping and using a vacuum with a High Efficiency Particulate Air (HEPA) filter are common methods for decontamination.

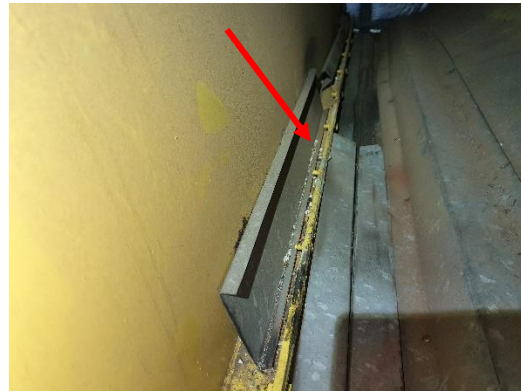
Image 2: Filter Room - Vermiculite debris

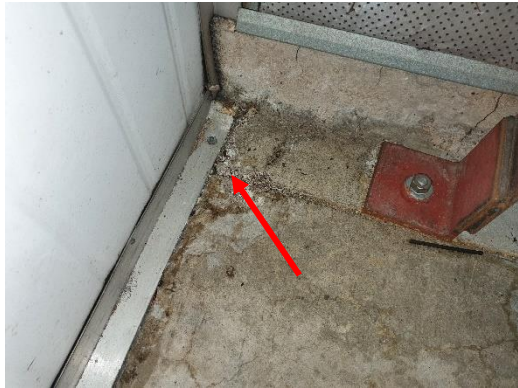
Image 3: Pre-Filter Room - Vermiculite debris

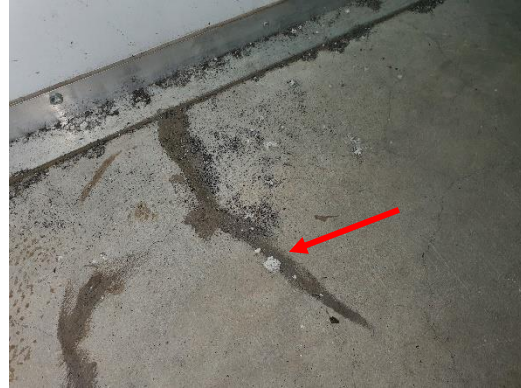
Image 4: Return Air Room - Vermiculite debris

| Sample Number | Sample Location | Sample Description | Sample Size | Asbestos Detected | Fibres Detected |
|---|---|---|---|---|---|
| B26767-S5 | Air Return Room - Floor | Debris | 0.2 gm | Yes | Chrysotile, Organic |

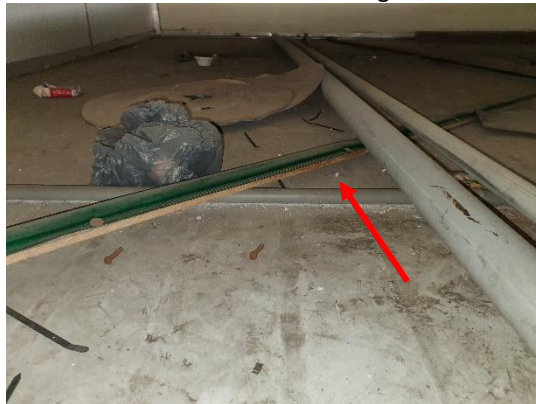
Image 5: 5th Floor Main Room - Vermiculite debris on top of North Plant

| Sample Number | Sample Location | Sample Description | Sample Size | Asbestos Detected | Fibres Detected |
|---|---|---|---|---|---|
| B26767-S8 | Top Of Duct - North Unit | Adhesive tape | N.A. | Yes | Chrysotile, Organic |

The removal of any materials within the 5th floor, apart from those brought in during maintenance as stated above, will need to be done so by a Class-A certified asbestos removalist.

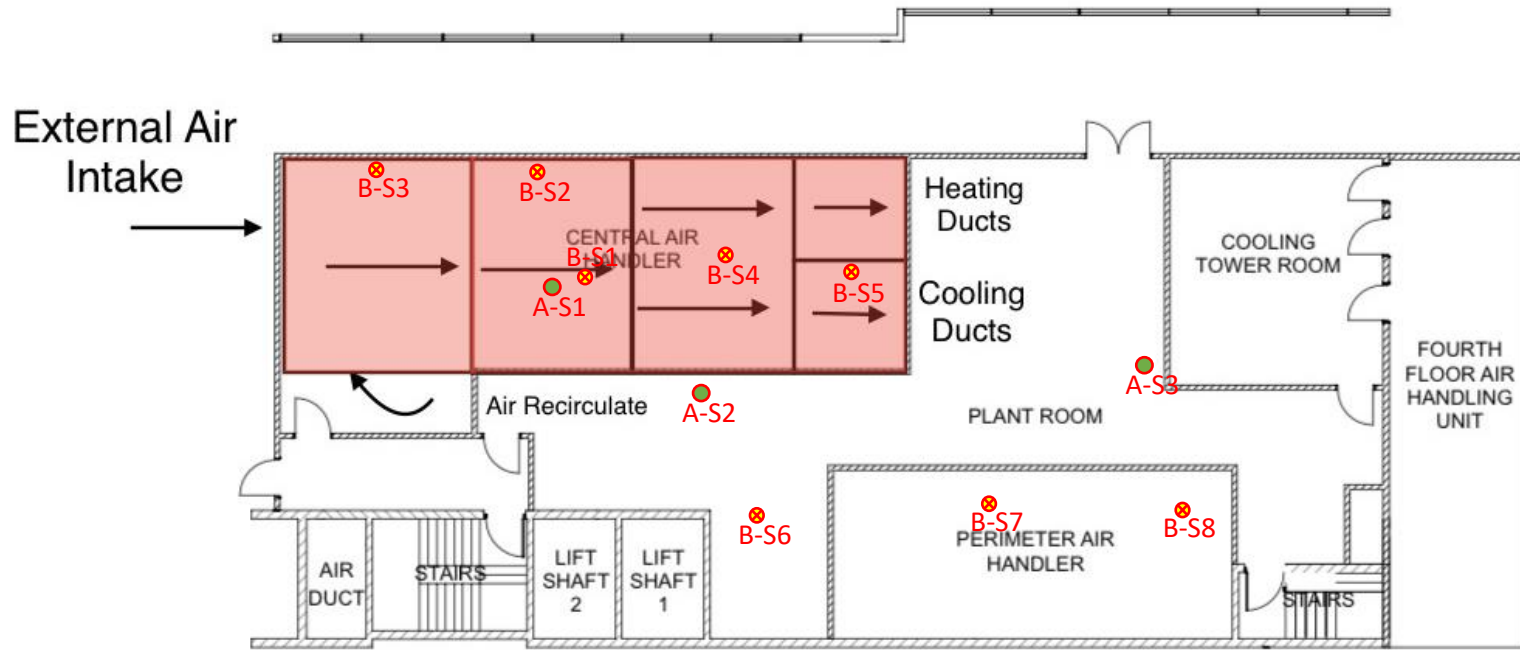
Sampling Locations on the 5th Floor of Ray Walsh House – Map Courtesy of Tamworth Regional Council

Note:
 A-S1 to A-S3 represent the approximate location of air samples.
 B-S1 to B-S8 represent the approximate location of debris and adhesive tape samples.
